TECHNICAL BULLETIN

ELECTRONICS DIVISION
DOCUMENT NR Ø35-643

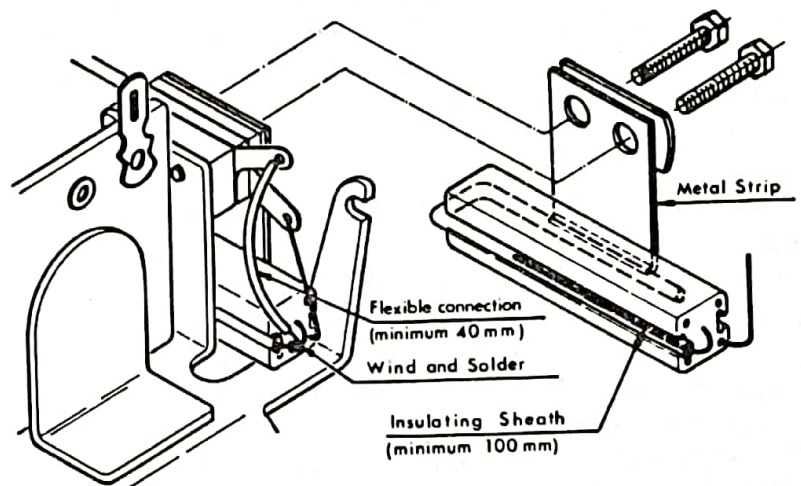
The right or left hand flipper vibrates when activated, because the centre terminal of the relevant 22 ohm resistor has been broken off.

As a result of the logical vibration created by the flipper assembly, and together with the thermal dissipation produced in the resistor, one of the terminals (normally the centre one) is broken or becomes faulty in its internal contact, producing the trouble referred to above. By incorporating the metal strip as shown on the figure we can drastically reduce the vibrations on the resistor, and by joining up the centre terminal by means of a flexible connection, we have completely eliminated any possible recurrence of this problem.

Replace the resistor connecting it exactly as shown on the figure below.

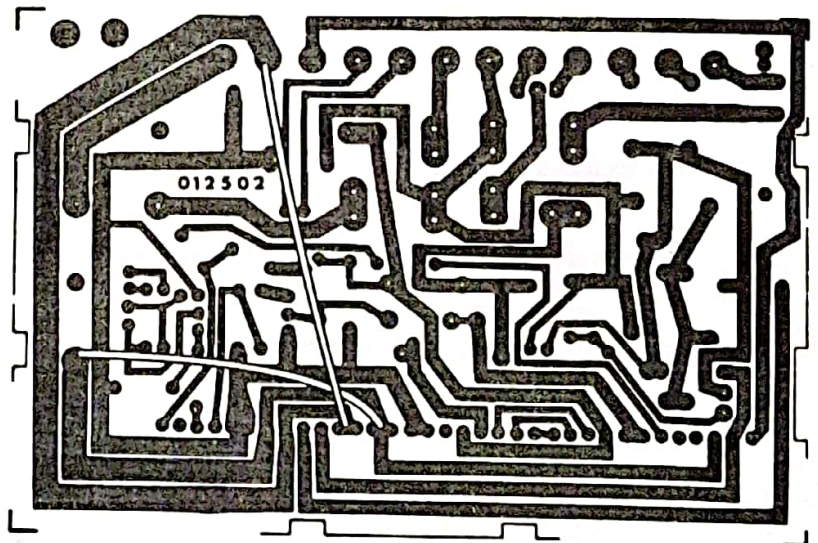
The right hand side of the Power Supply printed circuit board, can become considerably overheated and as a result you might experience a burning out of some contacts on the connector or the 6.3 volt tracks.

The stable illumination current (6.3 volts AC) heats the tracks by virtue of the Joule effect, and this heat is transferred to the pins on the connector, which deteriorates in turn the nylon supporting these pins.

Take out the circuit board, replace where necessary the connector if it has been damaged, and cable up the bridges exactly as shown in the figure below, between the points indicated.
